Property address:
23 Hollow Way
Brighton

Pre Purchase Property Inspection Report

Australian Property Surveyors
T: 0418 101 165 E: info@apsurveyors.com.au
Web: www.apsurveyors.com.au

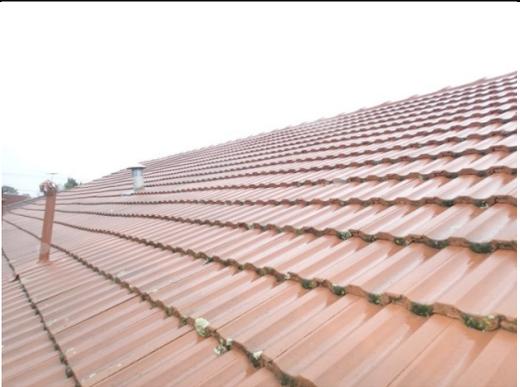
1.0 Roof coverings

| Defect/ Observation | Cracking/ broken tiles | |
| Location | External Roof coverings | |
| Comment | Ridge tiles appear recently replaced and repointed, some minor cracking. A few roof tiles have minor defects and need replacing. | |

| Recommendation | Replacement of affected roof tiles | |

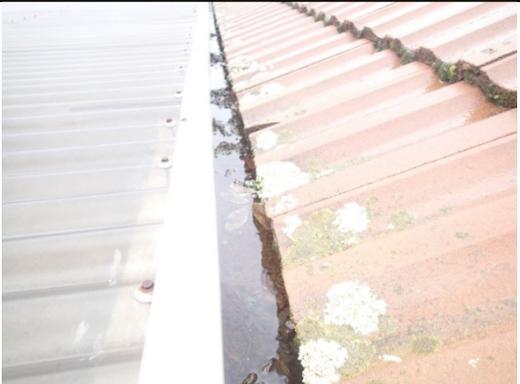
1.5 Gutters/ Downpipes

| Defect/ Observation | Insufficient fall to gutter. | |
| Location | Rear elevation | |
| Comment | Rear gutter is holding approx 25mm water, due to insufficient fall. There is some debris (cleaning out would improve drainage). | |

| Recommendation | Removal all dirt and debris to clean and flush out gutters. | |

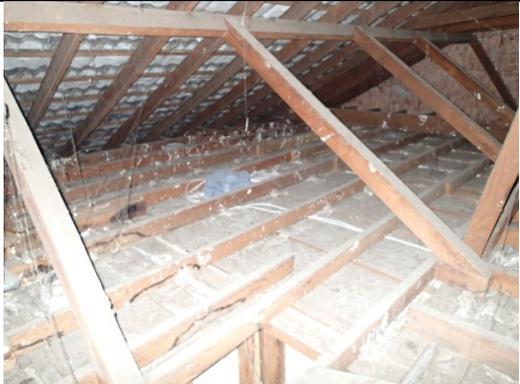
| 2.1 Insulation | | |

| 2.1 Insulation | | |
|---|--|---|
| Defect/ Observation | Lack of insulation | |
| Location | Roof space | |
| Comment | Existing roof insulation is patchy and inadequate and only covers half the total area. | |

| 2.1 Insulation | | |
|---|--|---|
| Recommendation | Replacement of insulation or additional insulation where lacking | |

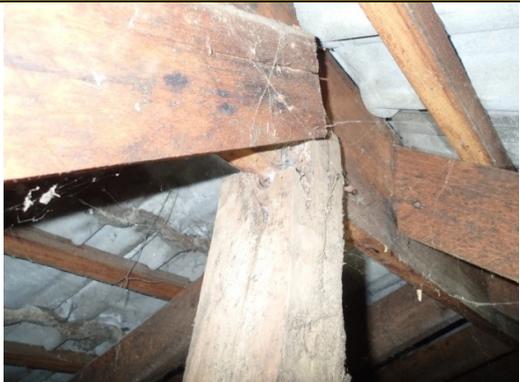
| 2.2 Timber beams | | |

| 2.2 Timber beams | | |
|---|---|--|
| Defect/ Observation | Lack of support for structural beams & rotten timbers | |
| Location | Roof trusses | |
| Comment | Some timber cross braces are only just being supported. Small amount of rot to the top of one timber post. | |

| 2.2 Timber beams | | |
|---|---|--|
| Recommendation | Engage a suitably qualified carpenter to replace and rectify. | |

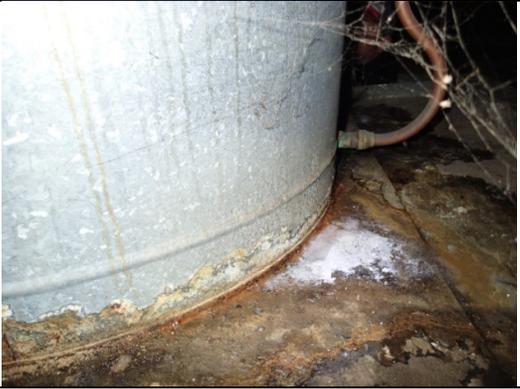
2.3 Water leaks

| Defect/ Observation | Rust/ leak | |
| Location | HWS in roof space | |
| Comment | HWS is rusted at the bottom and evidence of water leaking with rust to the tank and tray. | |

| Recommendation | Installation of a new HWS, externally at ground level, and drain and abandon the existing tank. | |

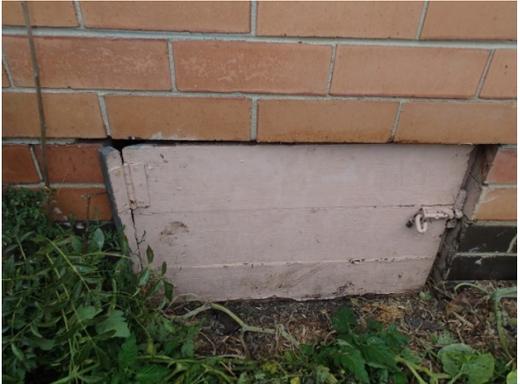
| Defect/ Observation | Broken door | |
| Location | Sub floor access door rear | |
| Comment | Timber door and frame are broken. | |

| Recommendation | Replacement with new door and frame. | |

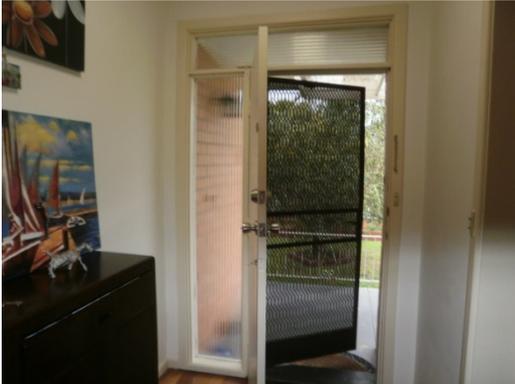
| 4.1.4 Doors | | |

| 4.1.4 Doors | | |
|---|--|---|
| Defect/ Observation | External door is hollow core | |
| Location | Front Door | |
| Comment | Hollow core doors are for use as interior doors as they are vulnerable to damage and cannot withstand extreme weather conditions, making them prone to water damage. | |

| 4.1.4 Doors | | |
|---|--|---|
| Recommendation | Replacement with new solid core door. | |

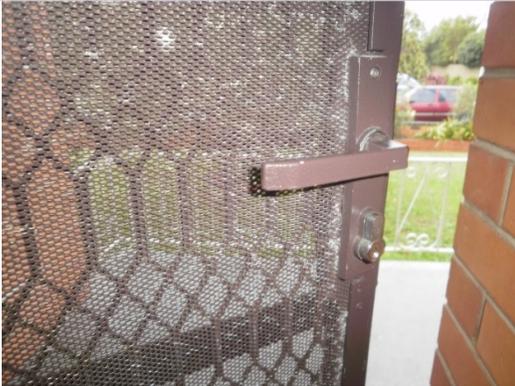
| 4.1.4 Doors | | |

| 4.1.4 Doors | | |
|---|--|--|
| Defect/ Observation | Front security door requires key to unlock from inside | |
| Location | Front Security Door | |
| Comment | Unable to be unlocked from inside without a key in the event of an emergency | |

| 4.1.4 Doors | | |
|---|--|--|
| Recommendation | Replacement with new security door. | |

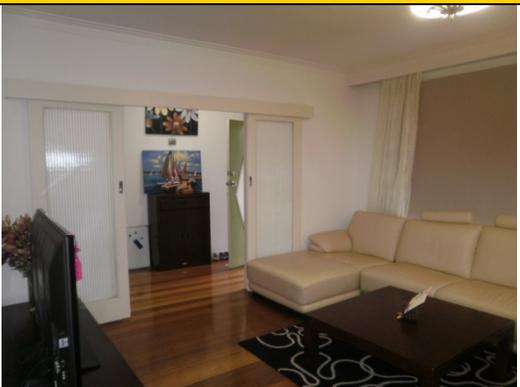
4.2.3 Windows

| Defect/ Observation | External aluminium windows | |
| Location | Lounge | |
| Comment | Unable to gain access to test if windows operational due to furniture hampering access | |

| Recommendation | That the windows are checked for workability. | |

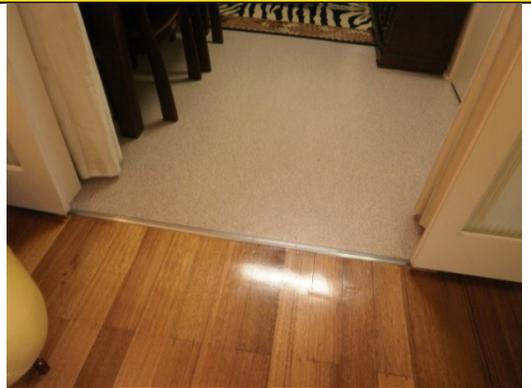
| Defect/ Observation | Sliding doors |
| Comment | Missing floor keeper. |
| Extent | All 4 internal sliding doors. |

| Recommendation | That floor keepers are installed to all sliding doors. |

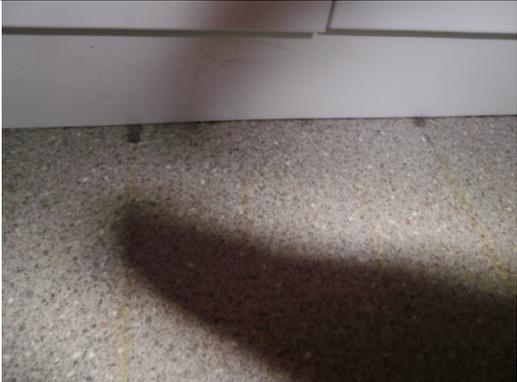
4.4.2 Floorcoverings

| Defect/ Observation | Damage to floorcoverings | |
| Location | Kitchen floor adjoining sink | |
| Comment | Slight damaged (indentions) to vinyl flooring | |

| Recommendation | Replacement of vinyl floorcoverings. | |

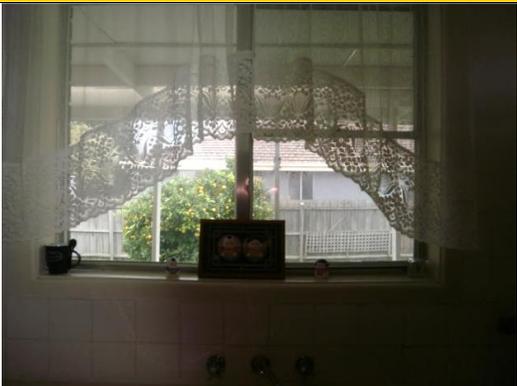
4.4.3 Windows

| Defect/ Observation | Very stiff to operate | |
| Location | Kitchen windows | |
| Comment | Window tracks are dirty and very stiff to open and close | |

| Recommendation | Clean and lubricate tracks, get windows serviced by tradesman. | |

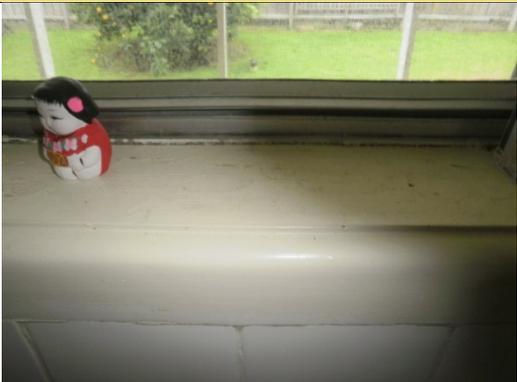
4.4.3 Windows

| Defect/ Observation | Paint peeling | |
| Location | Internal kitchen window sill | |
| Comment | Paint is peeling to the window sill | |

| Recommendation | Sand back, seal and repaint window frame. | |

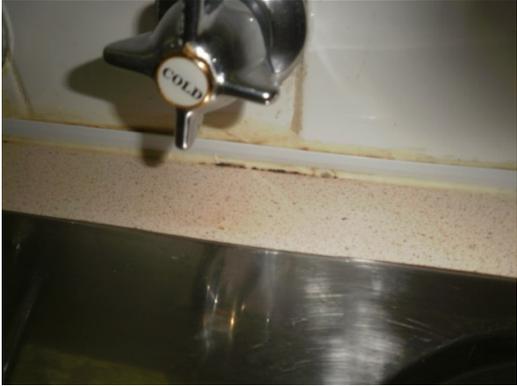
4.4.7 Benchtops

| Defect/ Observation | Damaged silicon seal | |
| Location | Kitchen joinery benchtop adjoining sink | |
| Comment | Silicon seal between joinery benchtop and splashback has got dirty and mould, damaged silicon has the potential to let water in which can damage the joinery | |

| Recommendation | Scrape out existing and replace with new silicon. | |

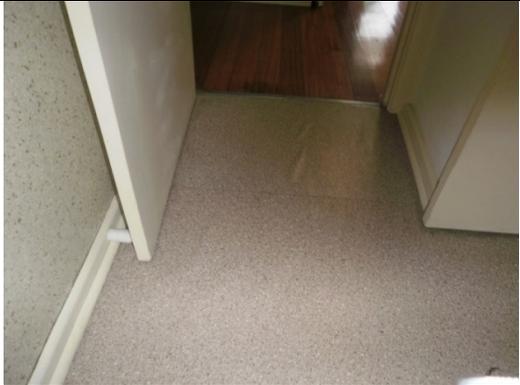
4.5.2 Floorcoverings

| Defect/ Observation | Lifted floorcovering | |
| Location | Laundry vinyl floor | |
| Comment | Vinyl floor has lifted | |

| Recommendation | Replace floorcoverings. Investigate further possibility of water damaged floor boards. | |

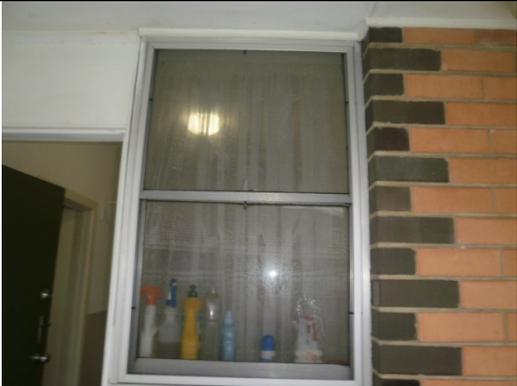
4.5.3 Windows

| Defect/ Observation | Window locked un-operable | |
| Location | Laundry window | |
| Comment | Laundry window was unable to be opened | |

| Recommendation | That the window is checked for workability. | |

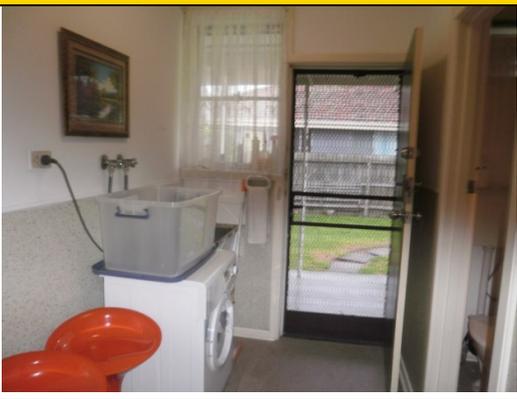
4.5.4 Doors

| Defect/ Observation | External door is hollow core | |
| Location | Rear laundry door | |
| Comment | Hollow core door are for use as interior doors as they are vulnerable to damage and cannot withstand extreme weather conditions, making them prone to water damage. | |

| Recommendation | Replacement with new solid core door. | |

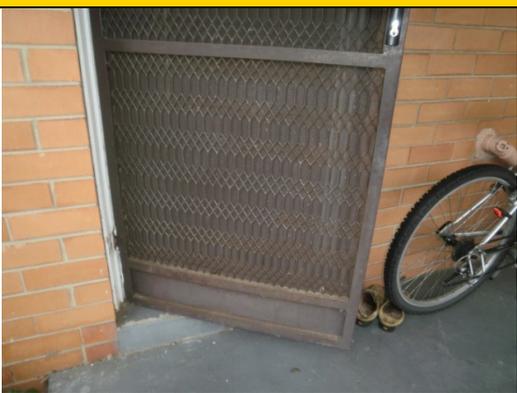
4.5.4 Doors

| Defect/ Observation | Rear security door requires two operations to open from inside when locked. Rust on the outside | |
| Location | Rear Security Door | |
| Comment | Unable to be opened in an emergency, when locked, with one operation of the door handle. Evidence of rust on the outside | |

| Recommendation | Replacement with new security door | |

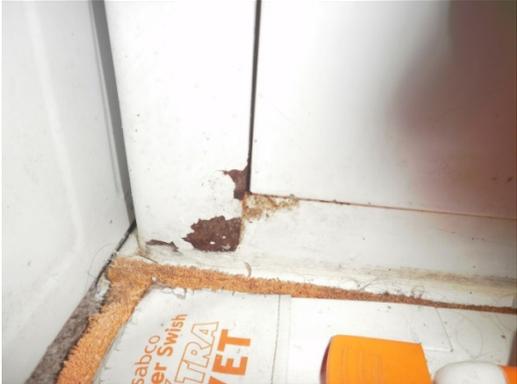
4.5.7 Laundry Tub

| Defect/ Observation | Rust | |
| Location | Laundry trough cabinet | |
| Comment | The cabinet to the laundry trough is rusted. | |

| Recommendation | Replacement with new cabinet. | |

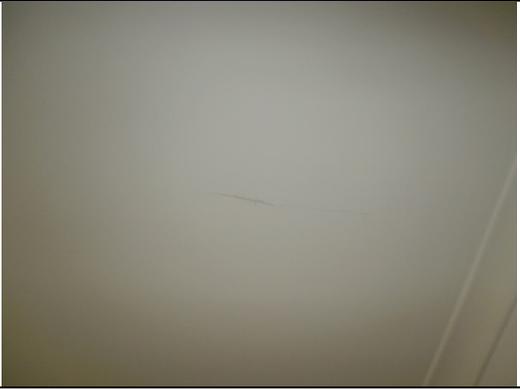
4.7.0 Ceilings

| Defect/ Observation | Moisture | |
| Location | Bathroom ceiling | |
| Comment | Evidence of moisture can be seen on ceiling in certain light. | |

| Recommendation | Engage a professional painter to seal and paint the ceiling. | |

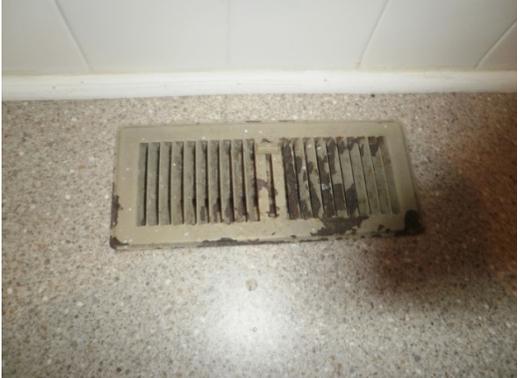
4.7.2 Floorcoverings

| Defect/ Observation | Rust | |
| Location | Bathroom floor vent | |
| Comment | The floor vent cover plate has evidence of rust | |

| Recommendation | Replacement of floor vent cover plate. | |

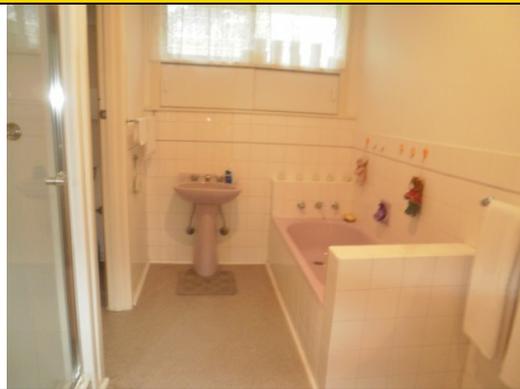
4.7.3 Windows

| Defect/ Observation | Window un-operable | |
| Location | Bathroom window | |
| Comment | Bathroom window is very stiff cannot be opened with extreme force | |

| Recommendation | Clean and lubricate tracks, get windows serviced by tradesman. | |

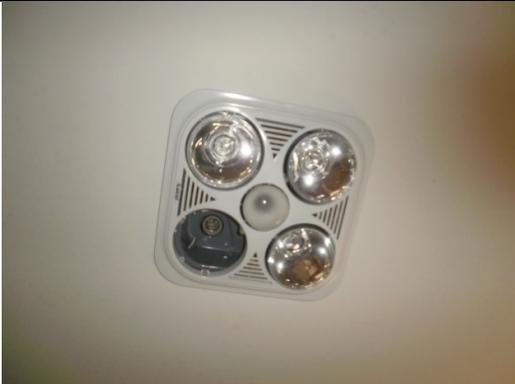
4.7.5 Lights

| Defect/ Observation | Missing heater globe | |
| Location | Bathroom ceiling exhaust fan/ light | |
| Comment | Heating globe is missing to combined exhaust fan/ light | |

| Recommendation | Replace globe | |

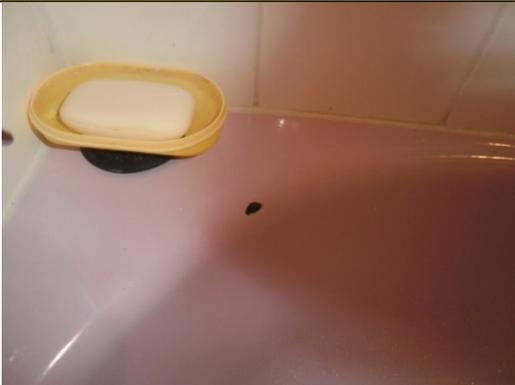
4.7.8 Bath

| Defect/ Observation | Chip in enamel | |
| Location | Bathtub | |
| Comment | Bathtub has small chip in the enamel paint covering | |

| Recommendation | Re-enamel of bathtub or replacement | |

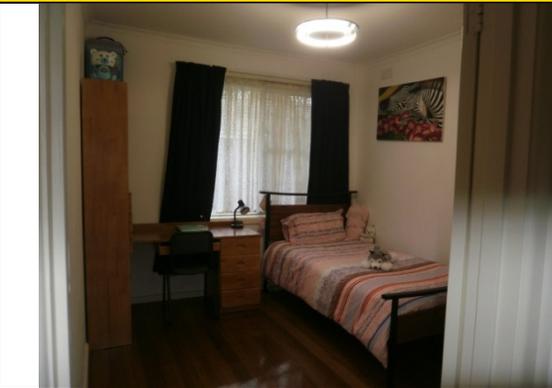
| 4.9.3 Windows | | |

| 4.9.3 Windows | | |
|---|--|---|
| Defect/ Observation | Window un-operable | |
| Location | Rear bedroom window | |
| Comment | Window is very stiff cannot be opened with extreme force | |

| 4.9.3 Windows | | |
|---|--|---|
| Recommendation | Clean and lubricate tracks, get windows checked and serviced by tradesman. | |

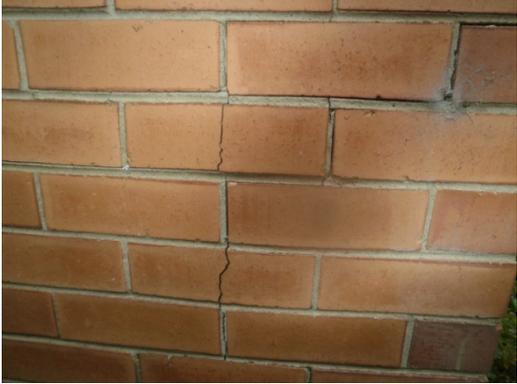
| External | |
|---|---|
| Walls | There is evidence of cracking to the external brick walls to the East, West and North elevations, we recommend you engage a structural engineer to investigate the cause and provide a recommendation. |

| 5.0 Walls | |
|---|--|
| Defect/ Observation | Cracking in external brick walls |
| Comment | Cracking to external brick walls, could be caused by movement/ structural damage |

| 5.0 Walls | |
|---|--|
| Recommendation | That you engage a qualified Structural Engineer to investigate, report, and recommend remedial action. |

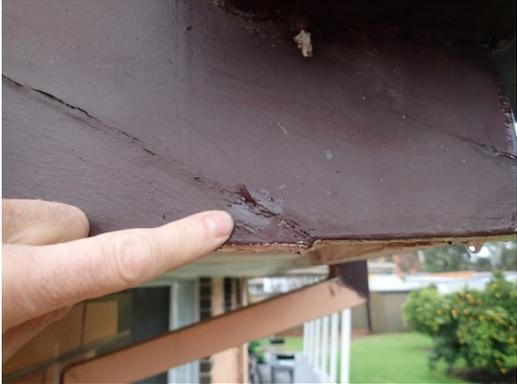
| 5.3 Bargeboard | |

| 5.3 Bargeboard | |
|---|---|
| Defect/ Observation | Rot |
| Comment | Timber bargeboard has evidence of rot and flaking paint. |

| 5.3 Bargeboard | |
|---|---|
| Recommendation | Engage a builder or suitably qualified tradesman to undertake replacement of any rotten timbers |

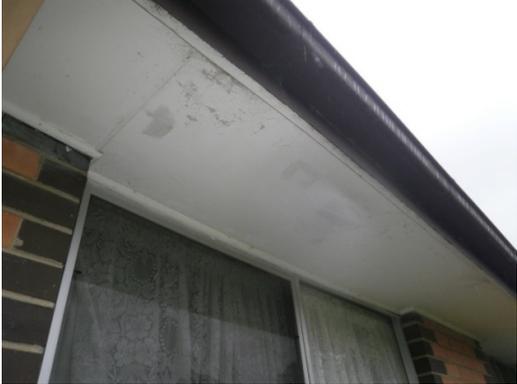
5.4 Eaves

| Defect/ Observation | Flaking paint. Unsecured eaves sheeting | |
| Location | Rear & front eaves sheeting | |
| Comment | Patches of flaking paint to rear. Section of eaves lining to the front outside lounge has dropped. | |

| Recommendation | Repainting required. Re-secure eaves sheeting. We recommend that you engage a qualified Asbestos inspector prior to undertaking any repairs or replacements to the eaves sheeting as they may contain asbestos. | |

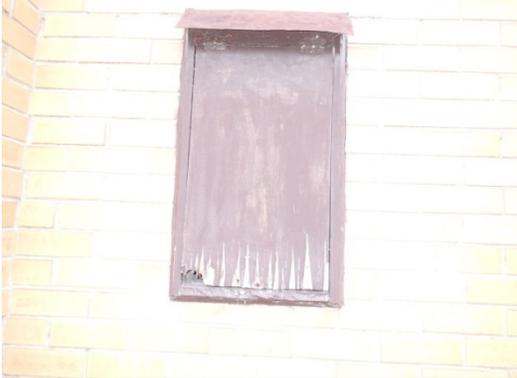
5.7 Electrical fuse box

| Defect/ Observation | Rotten timber | |
| Location | Electrical fuse box | |
| Comment | External timber door to electrical fuse box is rotten. | |

| Recommendation | Replacement of door. | |

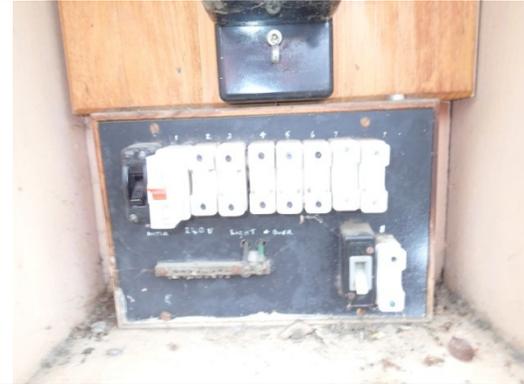
| Defect/ Observation | Old electrical fuse box |
| Comment | Old electrical fuse box, no RCD's. Requires updating. |

| Recommendation | Engage a qualified electrician to update the fuse box and to check the wiring throughout the house. |

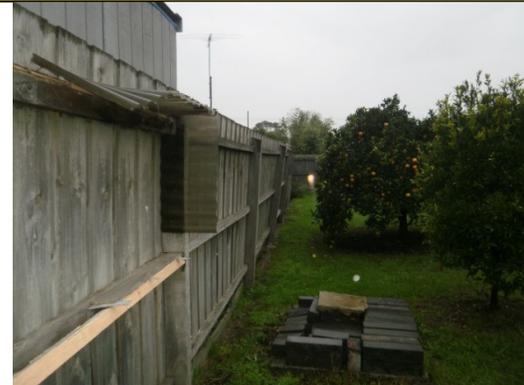
5.8 Fences

| Defect/ Observation | Leaning fence |
| Comment | The timber boundary fence to the rear is leaning in towards the subject site. |

| Recommendation | Install additional posts to prop fence and prevent further leaning. |

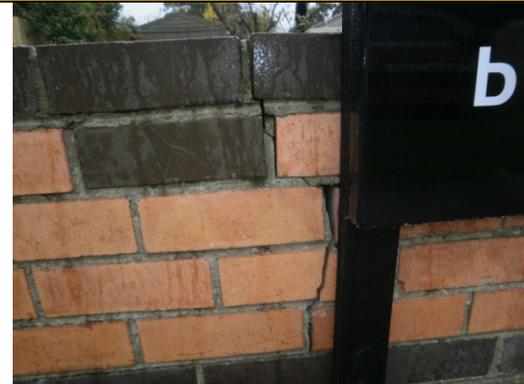
5.8 Fences

| Defect/ Observation | Cracked bricks |
| Comment | The front brick boundary fence has cracks in the brickwork from movement. |

| Recommendation | Engage a qualified builder to repair and or rebuild. |

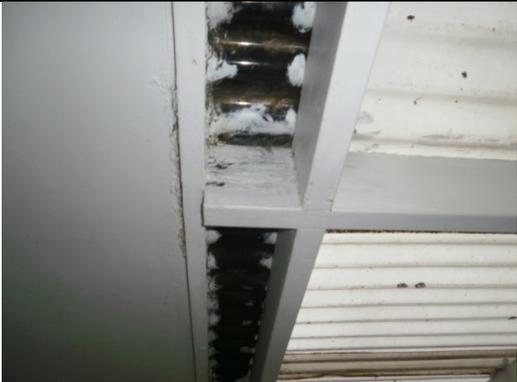
| 6.1.1 Beams | | |

| 6.1.1 Beams | | |
|---|---|--|
| Defect/ Observation | Rotten timber | |
| Location | To front verandah beams | |
| Comment | Rotten beams to front verandah | |

| 6.1.1 Beams | | |
|---|---|--|
| Recommendation | Replacement of rotten timbers by a qualified builder/ tradesman | |

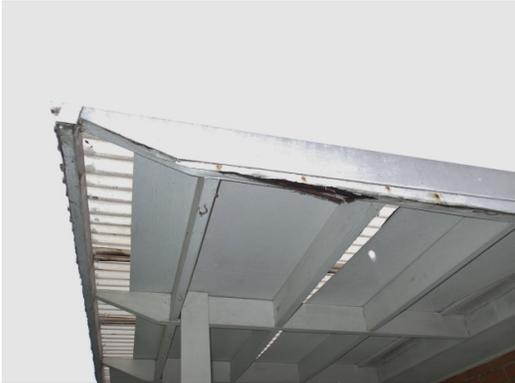
| 6.2.1 Beams | | |

| 6.2.1 Beams | | |
|---|--|--|
| Defect/ Observation | Rotten timber | |
| Location | To rear verandah beams | |
| Comment | Rotten side west fascia beam and east beam is likely to be rotten. | |

| 6.2.1 Beams | | |
|---|--|--|
| Recommendation | Replacement of rotten timbers by a qualified builder/ tradesman | |

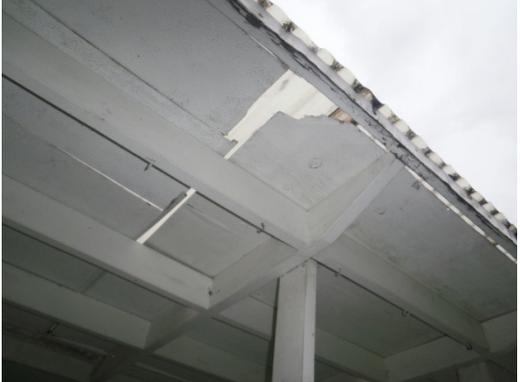
6.2.2 Roof coverings

| Defect/ Observation | Broken/ unsecure soffit lining | |
| Location | To rear verandah | |
| Comment | Poorly installed soffit lining under the clear corrugated sheeting, broken and inadequately supported in places | |

| Recommendation | Replacement or complete removal of soffit lining. | |

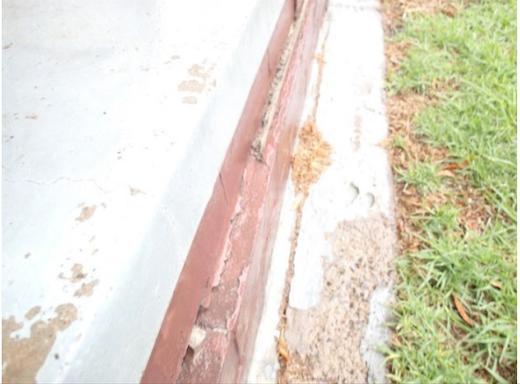
6.2.3 Rear Verandah Floor

| Defect/ Observation | Movement to brick supporting wall | |
| Location | To rear verandah floor | |
| Comment | The brick support wall has moved outwards which supports the concrete slab floor to the rear verandah | |

| Recommendation | Engage a qualified builder to assess the extent of the damage, and repair or replacement of the brick supporting wall if required. | |
