Property address:
23 Hollow Way
Brighton

Pre Purchase Property Inspection Report

Australian Property Surveyors
T: 0418 101 165 E: info@apsurveyors.com.au
Web: www.apsurveyors.com.au

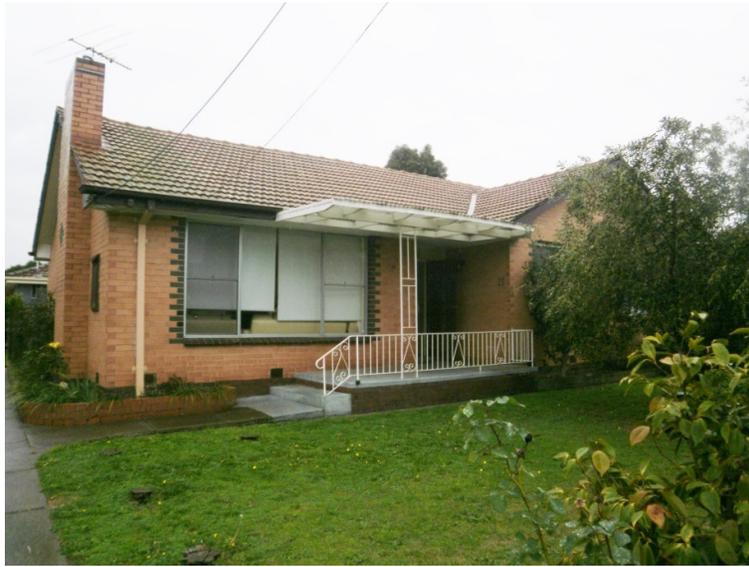
Main building

| External | |
|---|---|
| Walls | There is evidence of cracking to the external brick walls to the East, West and North elevations, we recommend you engage a structural engineer to investigate the cause and provide a recommendation. |

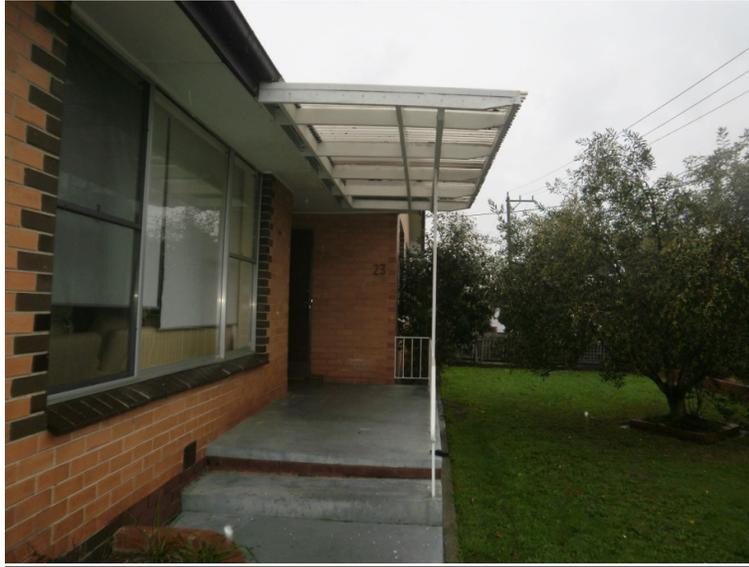
6.1 Front Verandah

| External | |
|---|---|
| Outbuildings | Front and rear verandahs have rotten beams, these will require replacement to prevent further rot and damage. Garage is in poor condition and the front door is unopenable and there is evidence of rust and water damage to the roof. |

| 6.1.1 Beams | | |
|---|---|--|
| Recommendation | Replacement of rotten timbers by a qualified builder/ tradesman | |
